NASA/TP-97-206257

The Characteristics of Fatigue Damage in the Fuselage Riveted Lap Splice Joint

Robert S. Piascik
Langley Research Center, Hampton, Virginia

November 1997

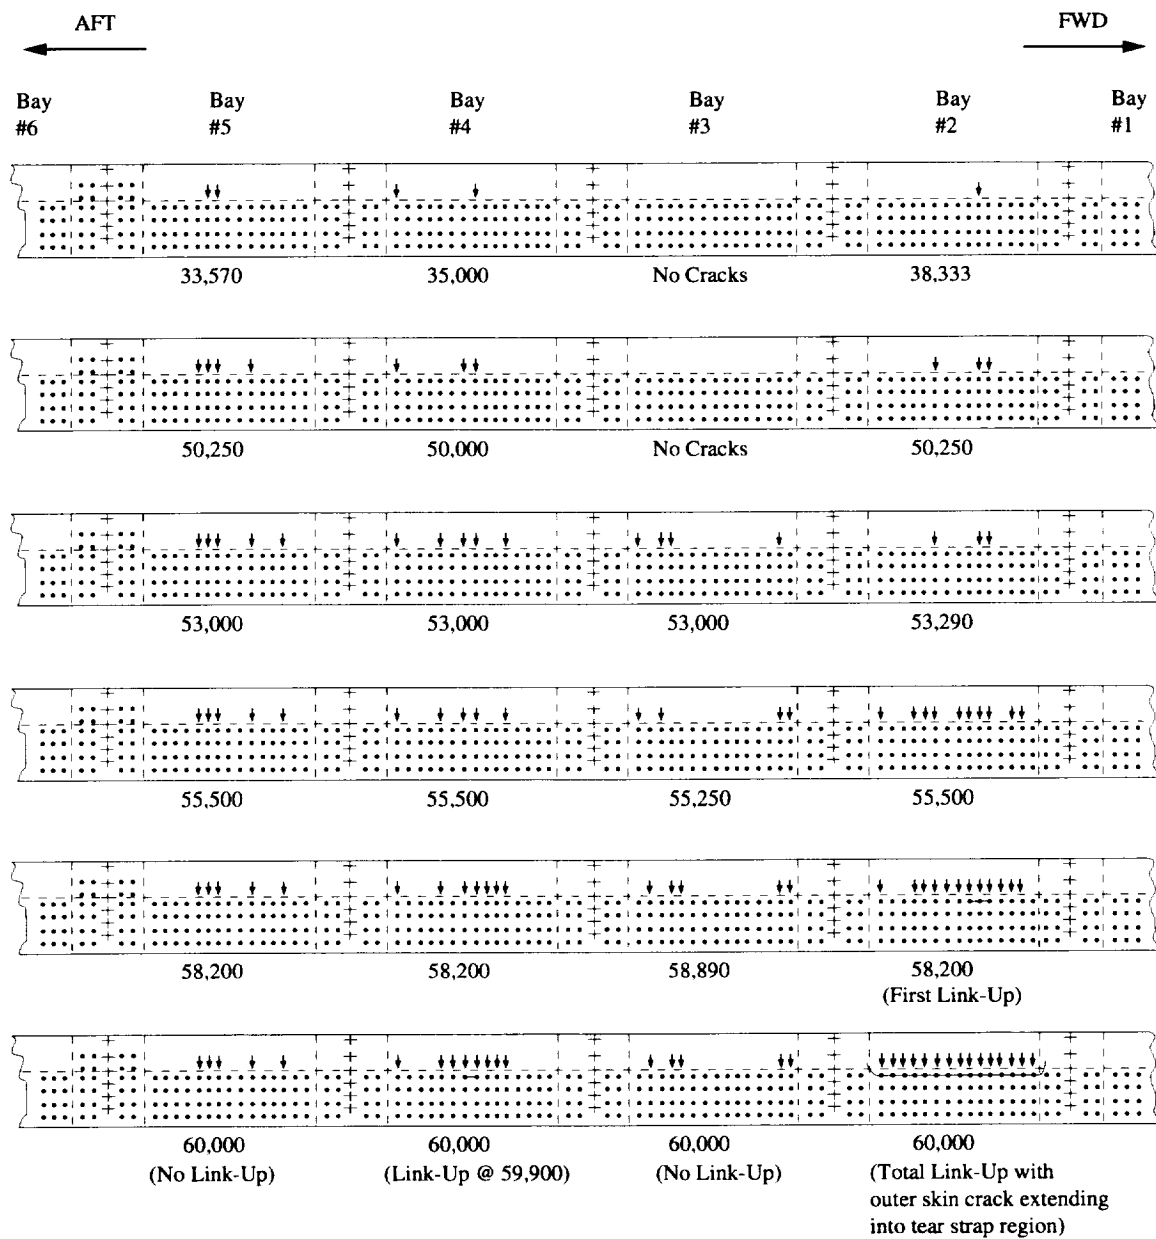
Figure 2.1 The schematics show the results of the *in situ* inspection. Arrows indicate rivet hole locations that contain visible fatigue cracks. Cycle counts associated with the visual observations are located below each schematic. Crack link-up occurred in bay 2 and bay 4.

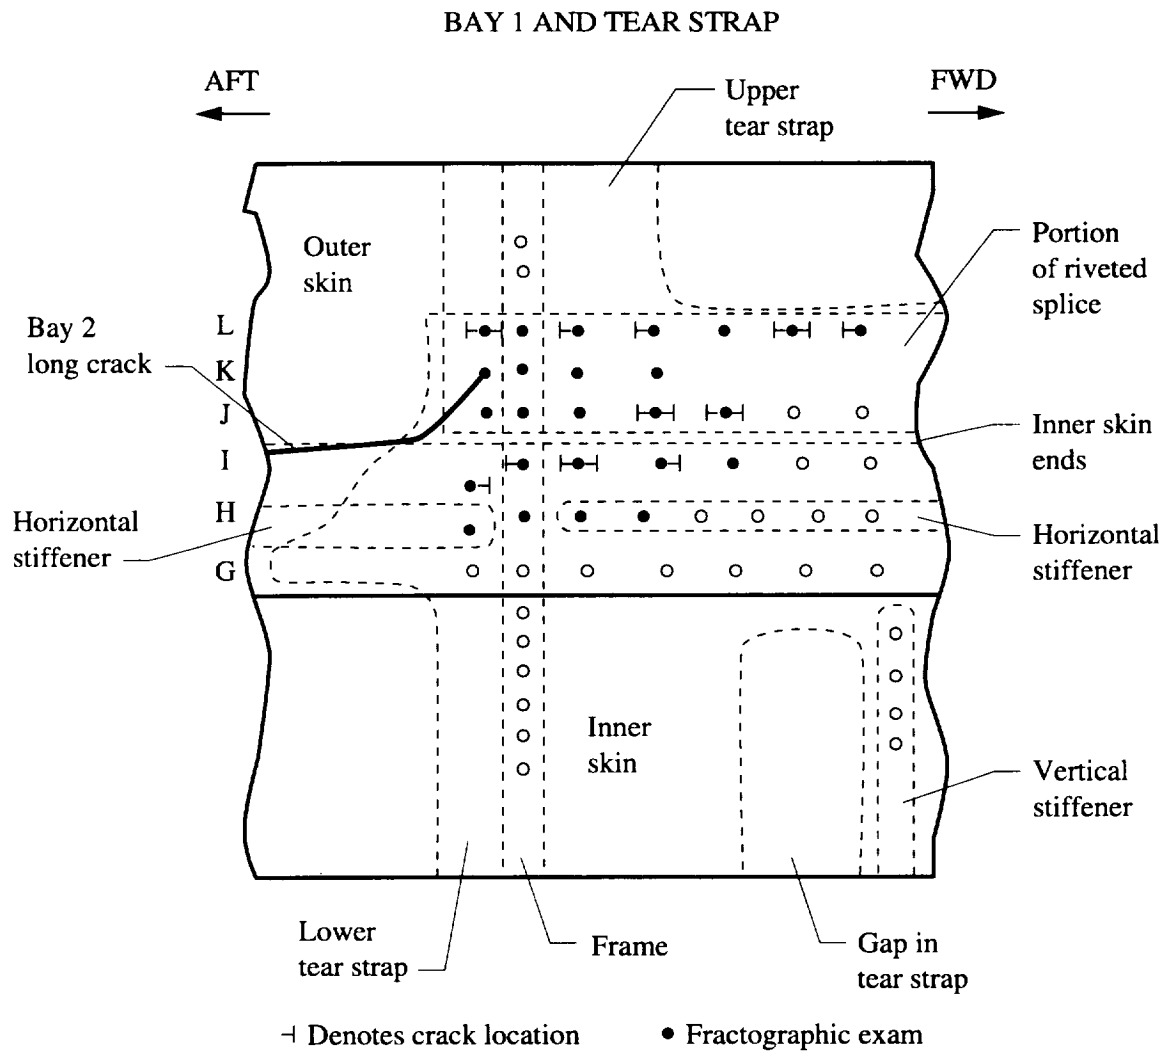
Figure 6.1 The schematic shows the location of all fatigue cracks found in the bay 1 tear strap and lap splice joint regions by destructive examination. Fractographic examinations were performed on the hole locations marked by the solid circles. Note the dark solid line that marks the location of the long crack extending from bay 2.

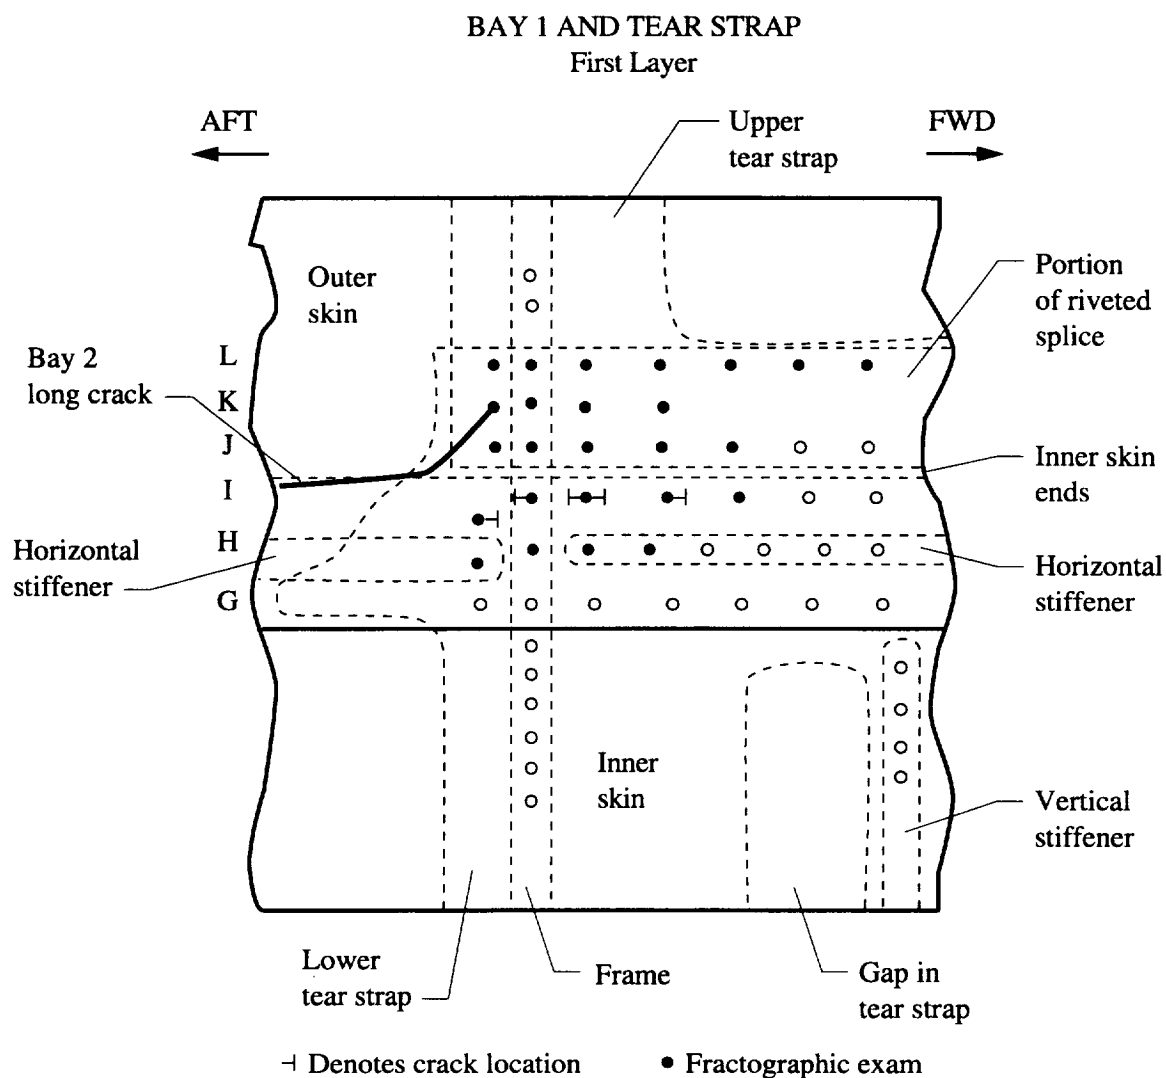
Figure 6.2 The schematic shows the location of fatigue cracks found in the first layer (outer skin) of the bay 1 tear strap and lap splice joint regions by destructive examination. One end of the long bay 2 fatigue crack (dark solid line) extended into this region.

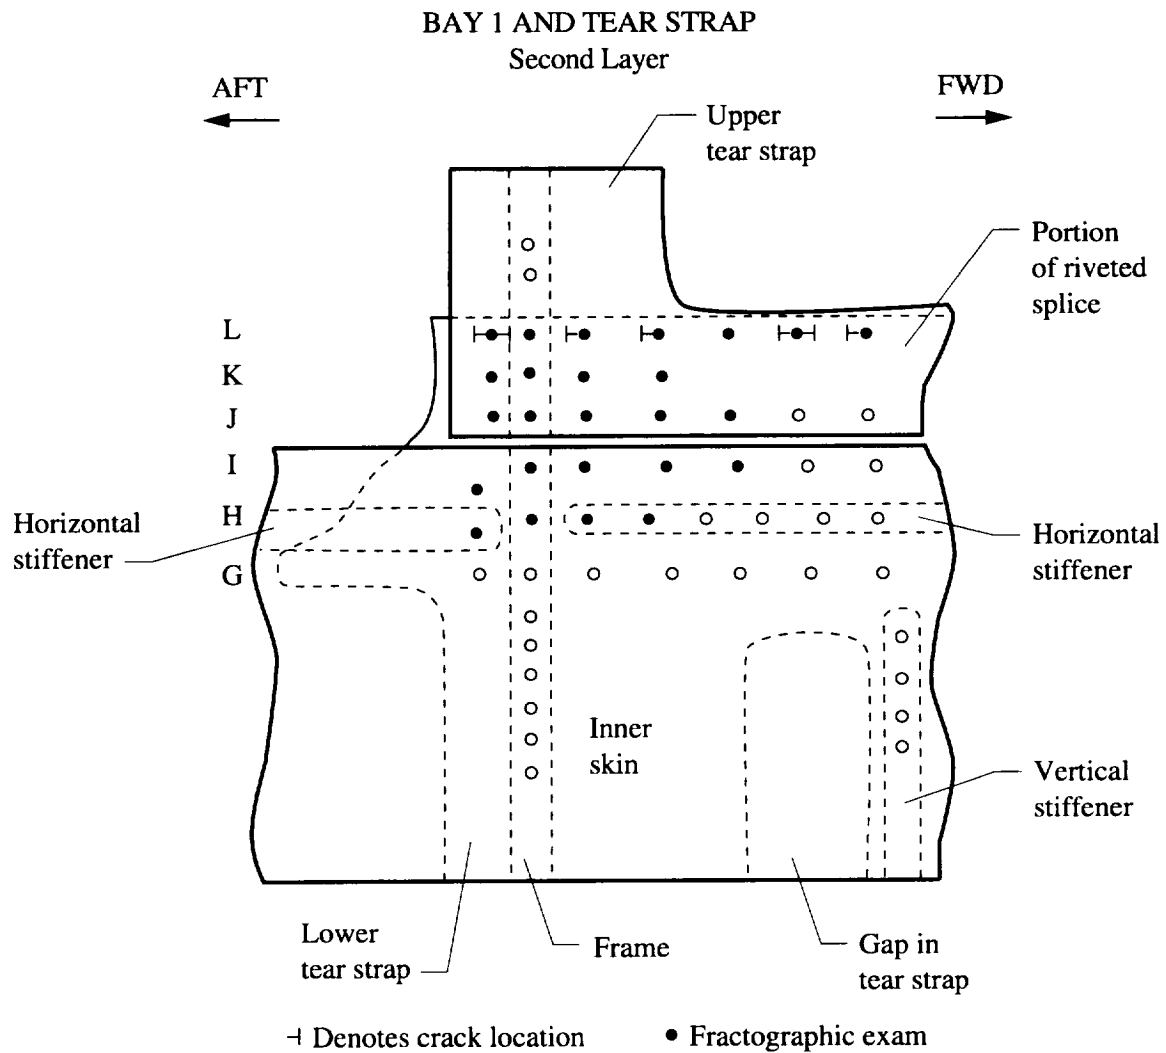
Figure 6.3 The schematic shows the location of fatigue cracks found in the second layer (upper tear strap and inner skin) of the bay 1 tear strap and lap splice joint regions by destructive examination.

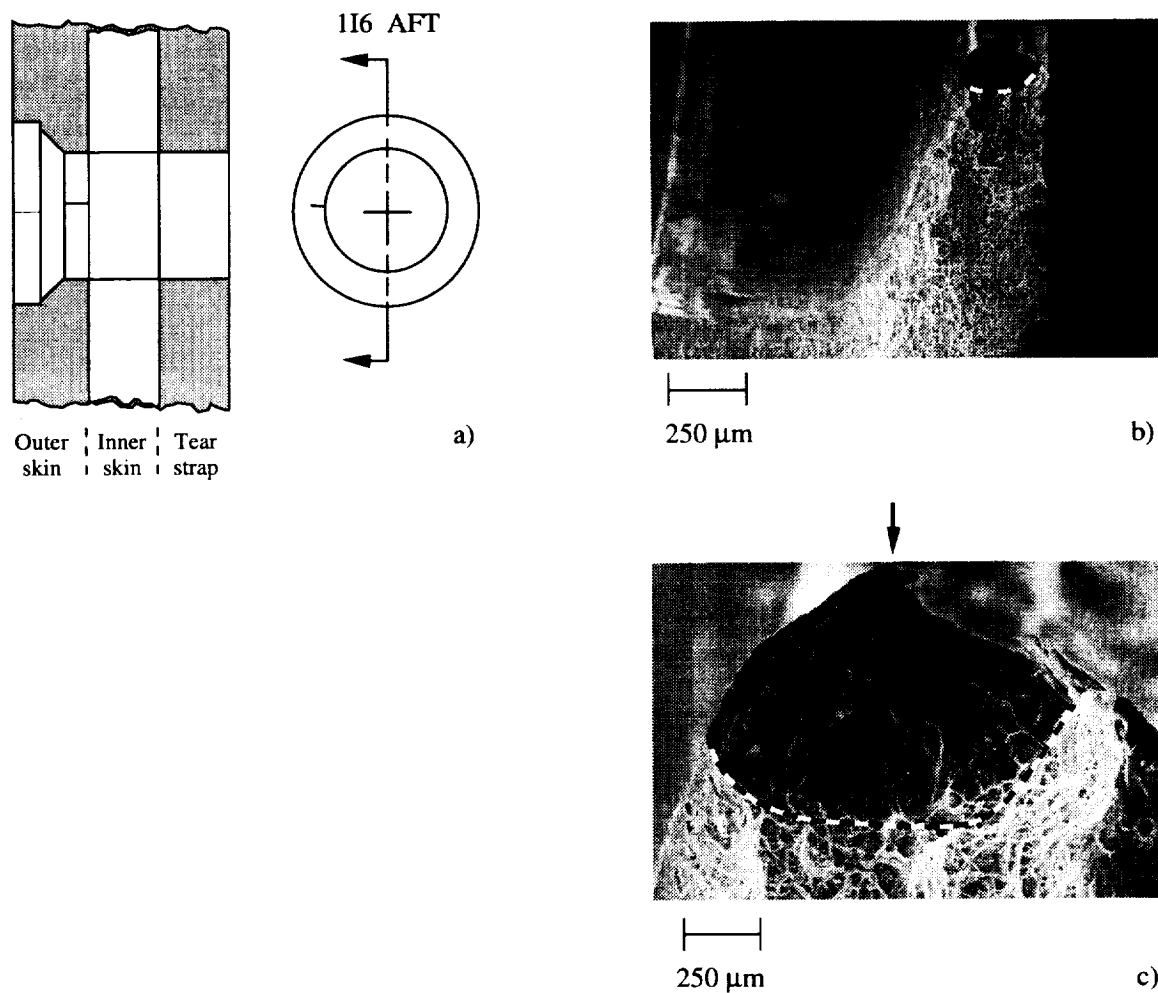
Figure 6.9 a) The schematic shows the rivet hole 1I6 configuration and the location of the outer skin fatigue crack oriented in the aft direction slightly above the 9 o'clock position. b) The SEM micrograph shows the fatigue crack location within the rivet hole. The dashed line marks the fatigue crack front. c) The SEM micrograph shows the fatigue crack region at higher magnification. The arrow marks the likely site of crack initiation. The dashed line marks the fatigue crack front.

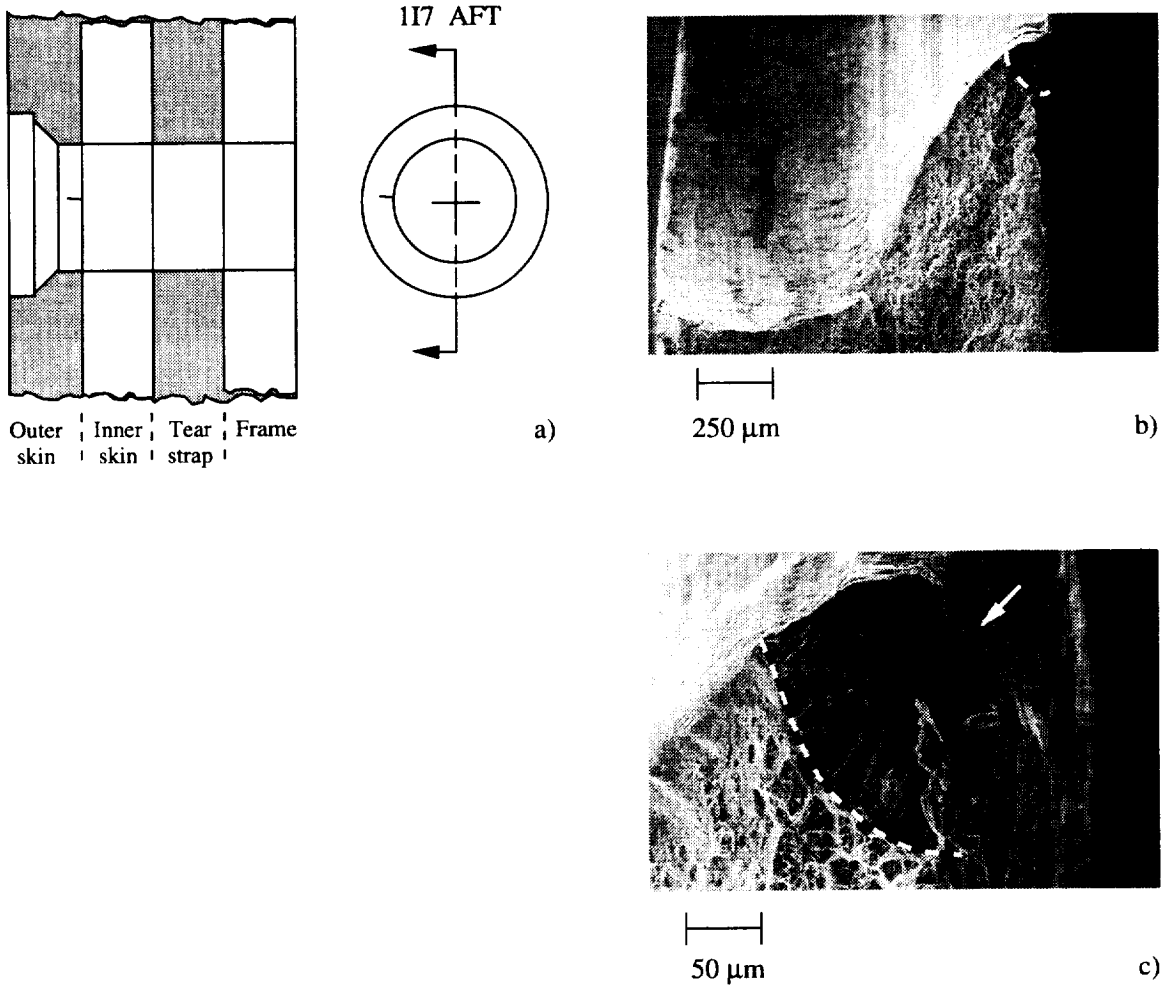
Figure 6.11 a) The schematic shows the rivet hole 117 configuration and the location of the outer skin fatigue crack oriented in the aft direction slightly above the 9 o'clock position. b) The SEM micrograph shows the fatigue crack location within the rivet hole. The dashed line marks the fatigue crack front. c) The SEM micrograph shows the fatigue crack region at higher magnification. The arrow marks the likely site of crack initiation.

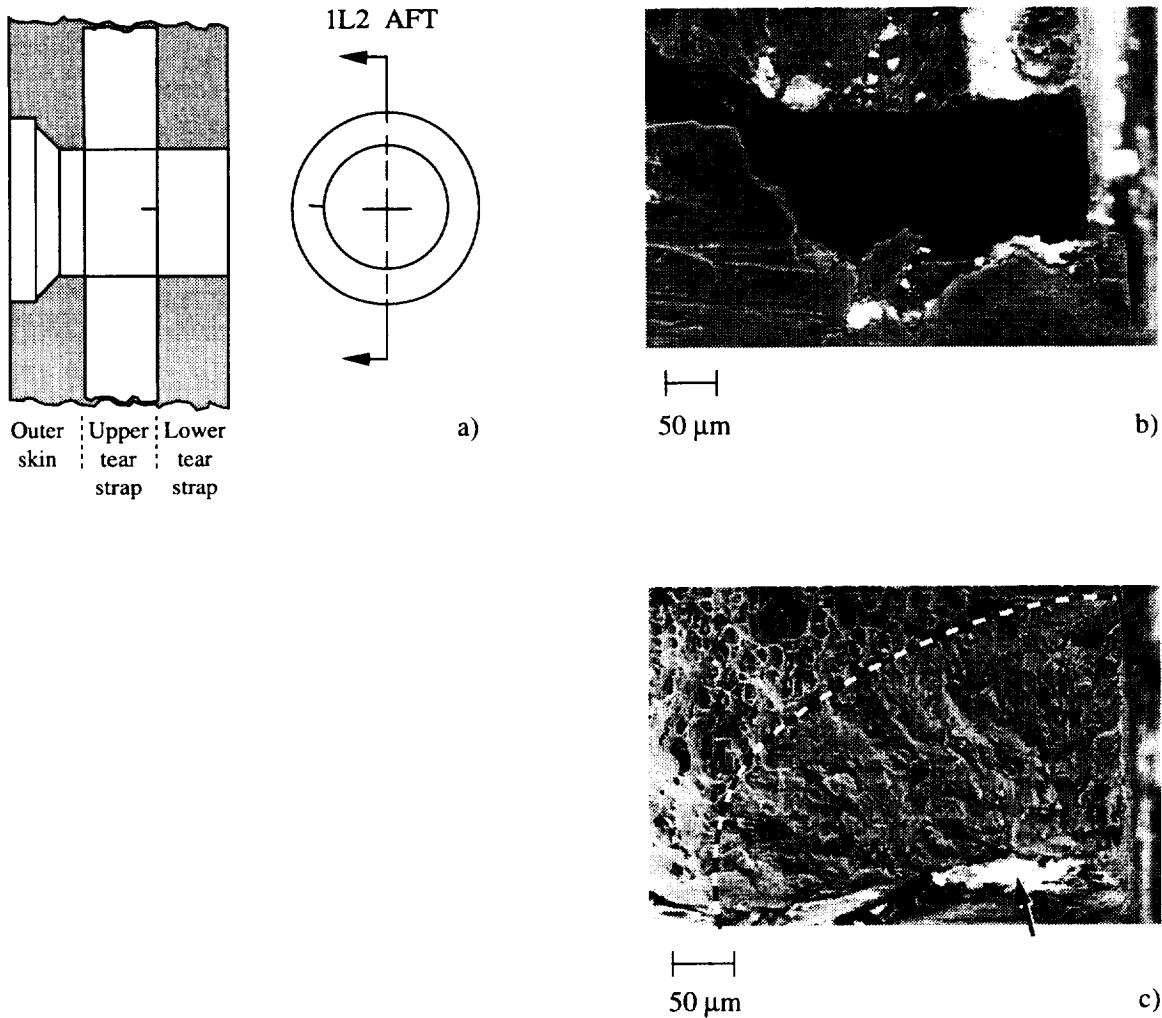
Figure 6.13 a) The schematic shows the rivet hole 1L2 configuration and the location of the upper tear strap fatigue crack oriented in the aft direction slightly above the 9 o'clock position. b) The SEM micrograph shows the corner fatigue crack that has been partially opened during the destructive examination. The surface normal to the fatigue crack is the hole inside surface. This surface exhibits a roughened morphology and oxide debris is observed adjacent to the crack lip. The white color of this debris is associated with electronic charging during the SEM examination and is typically caused by nonconducting surface oxides. c) The SEM micrograph shows the fatigue crack region after final fracture of the specimen. The dashed line marks the fatigue crack front. An arrow marks the likely region of crack initiation which exhibits a rough surface containing oxide debris (white region).

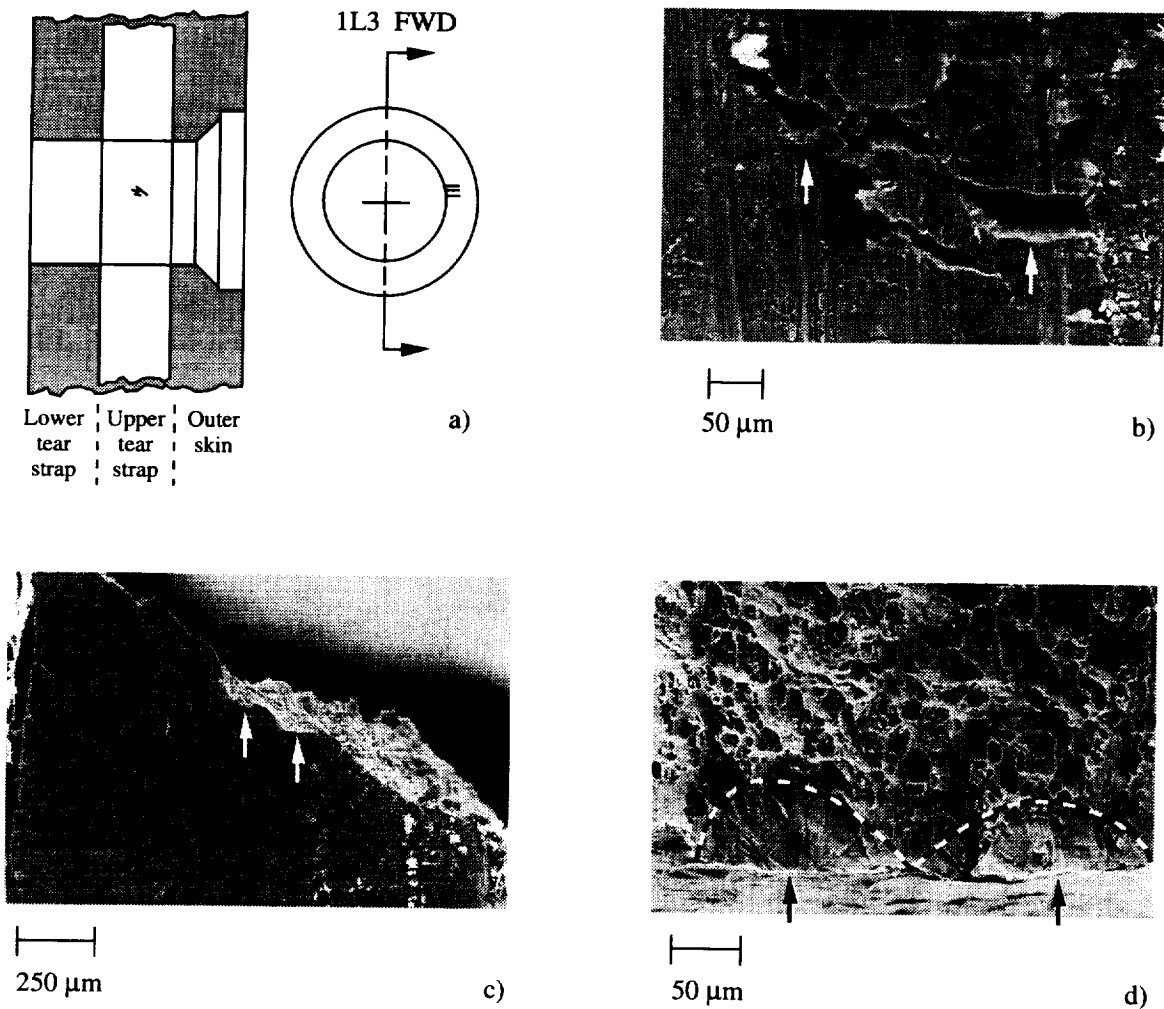
Figure 6.14 a) The schematic shows the rivet hole 1L3 configuration and the location of the upper tear strap fatigue crack oriented in the forward direction at about the 3 o'clock position. b) The SEM micrograph shows the surface fatigue cracks that have been partially opened during the destructive examination. Note the vertical marking on the inside surface of the hole. These markings suggest possible disturbed surface metal in the region of crack initiation marked by the arrows. c) The SEM micrograph shows the fatigue crack location within the rivet hole after the specimen was fractured. Arrows mark approximate regions of fatigue crack initiation. d) The SEM micrograph shows the fatigue fracture surface. The dashed line marks the fatigue crack front. Arrows mark approximate regions of fatigue crack initiation.

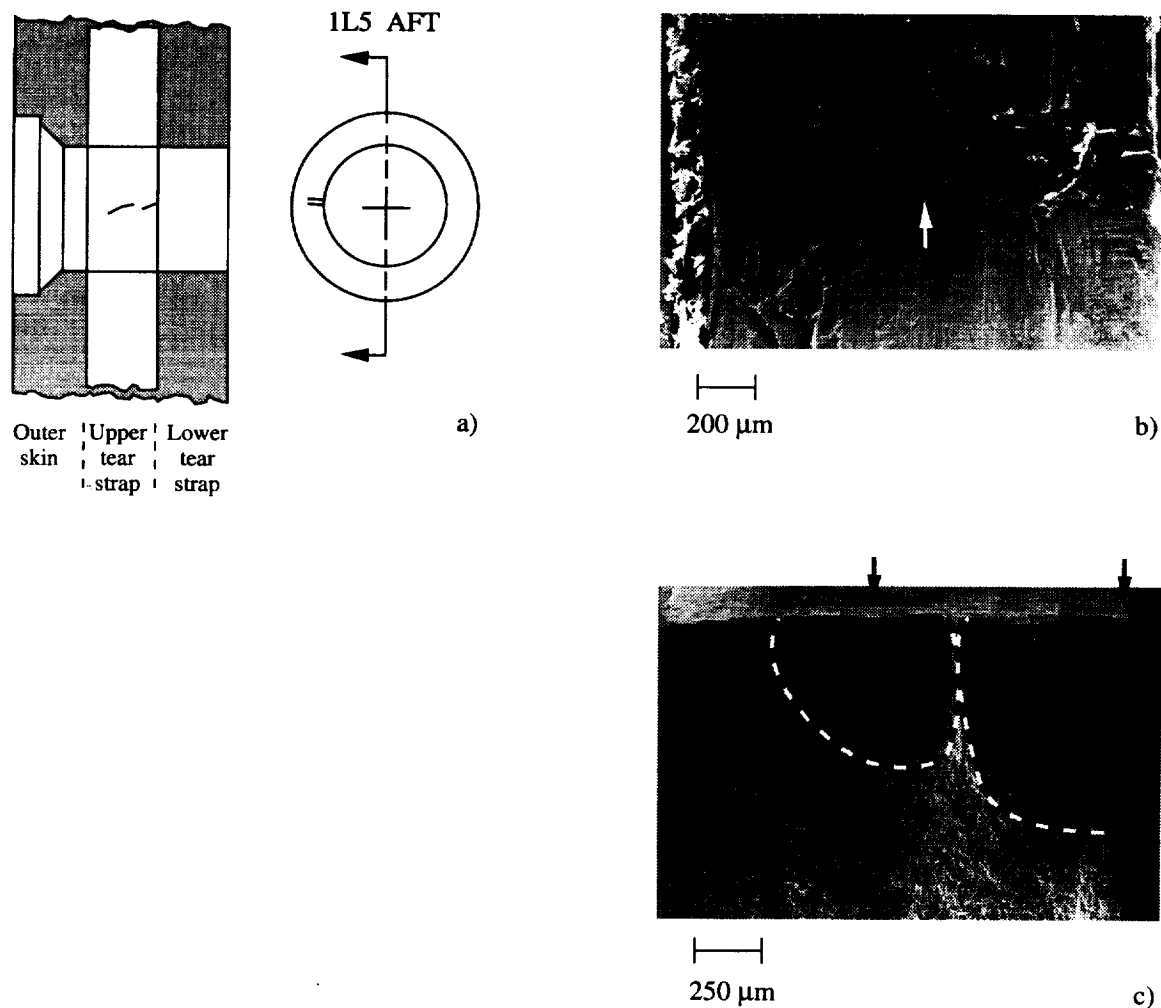
Figure 6.16 a) The schematic shows the rivet hole 1L5 configuration and the location of the upper tear strap fatigue cracks oriented in the aft direction and about the 9 o'clock position. b) The SEM micrograph shows the multiple surface and corner fatigue cracks that have been partially opened during the destructive examination. Arrows mark approximate sites of crack initiation. c) The SEM micrograph shows the fatigue fracture surface of the corner and surface crack. The dashed line marks the fatigue crack front. Note that crack-to-crack interaction has altered the shape of each crack front (marked by dashed lines). Arrows mark the approximate location of crack initiation.

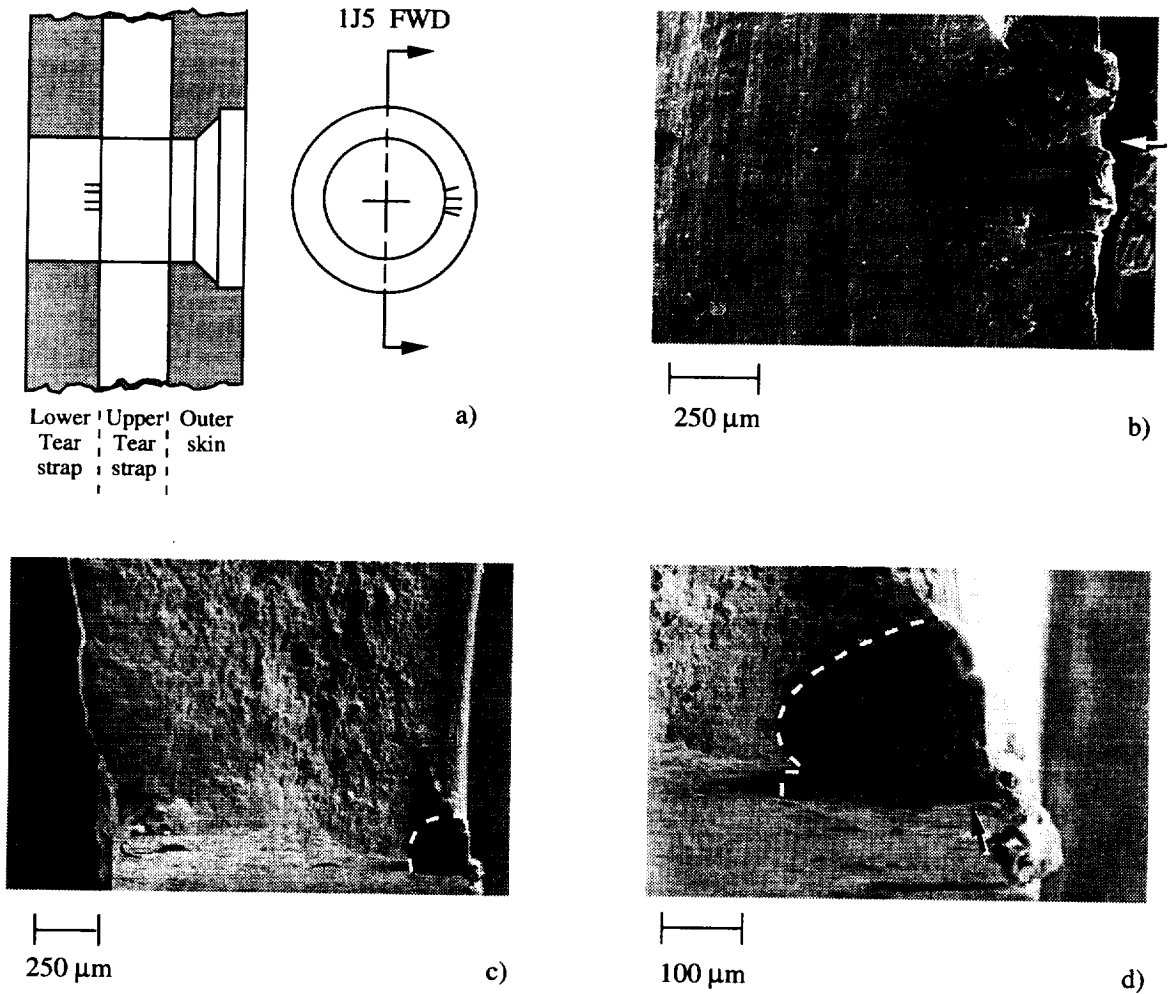
Figure 6.22 a) The schematic shows the rivet hole 1J5 configuration and the location of the multiple lower tear strap corner fatigue cracks oriented in the forward direction and about the 3 o'clock position. b) The SEM micrograph of the rivet hole surface shows the region that contains multiple corner cracks. Note the corner burrs near the likely point of crack initiation. The arrow marks the position of the fracture shown in Figures 6.22.c and 6.22.d. c) The SEM micrograph shows the fracture surface of the corner crack marked by the arrow in Figure 6.22.b. The dashed line marks the fatigue crack front. d) The SEM micrograph shows the fracture surface of the corner crack in Figure 6.22.c at higher magnification. The dashed line marks the fatigue crack front and the arrow marks the likely site of fatigue crack initiation.

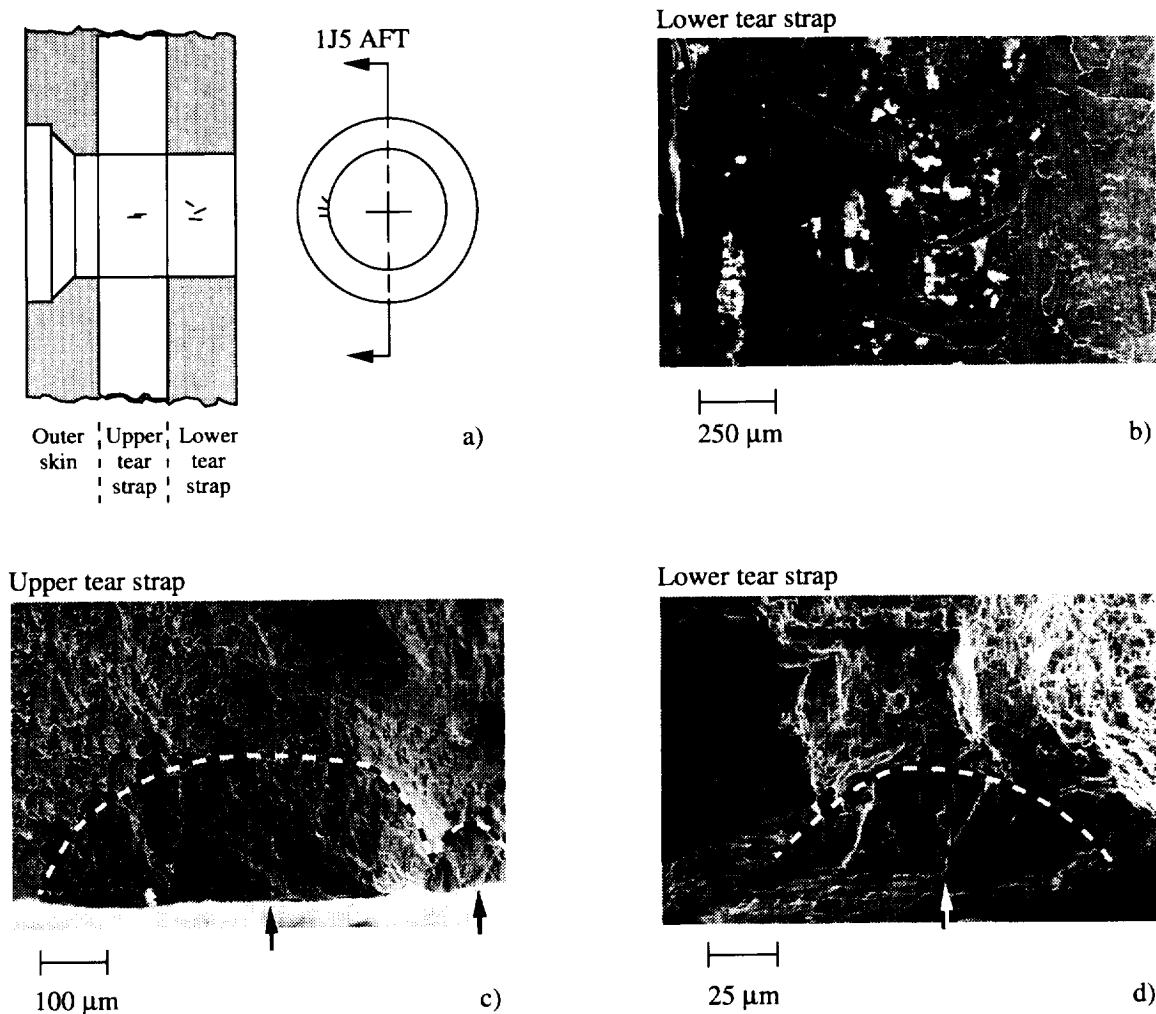
Figure 6.23 a) The schematic shows the rivet hole 1J5 configuration and the location of upper and lower tear strap fatigue cracks oriented in the aft direction and about the 9 o'clock position. b) The SEM micrograph shows the inside surface of the lower tear strap rivet hole and multiple fatigue surface cracks partially opened as a result of the destructive examination straining operation. c) The SEM micrograph shows the fatigue fracture surface of the upper tear strap rivet hole surface cracks. The dashed line marks the fatigue crack front and arrows mark the likely sites of fatigue crack initiation. The irregular shape of the crack front is due to multiple crack coalescence. d) The SEM micrograph shows the fatigue fracture surface of the lower tear strap rivet hole surface crack (upper most crack in Figure 6.23.b). An arrow marks the site of crack initiation.

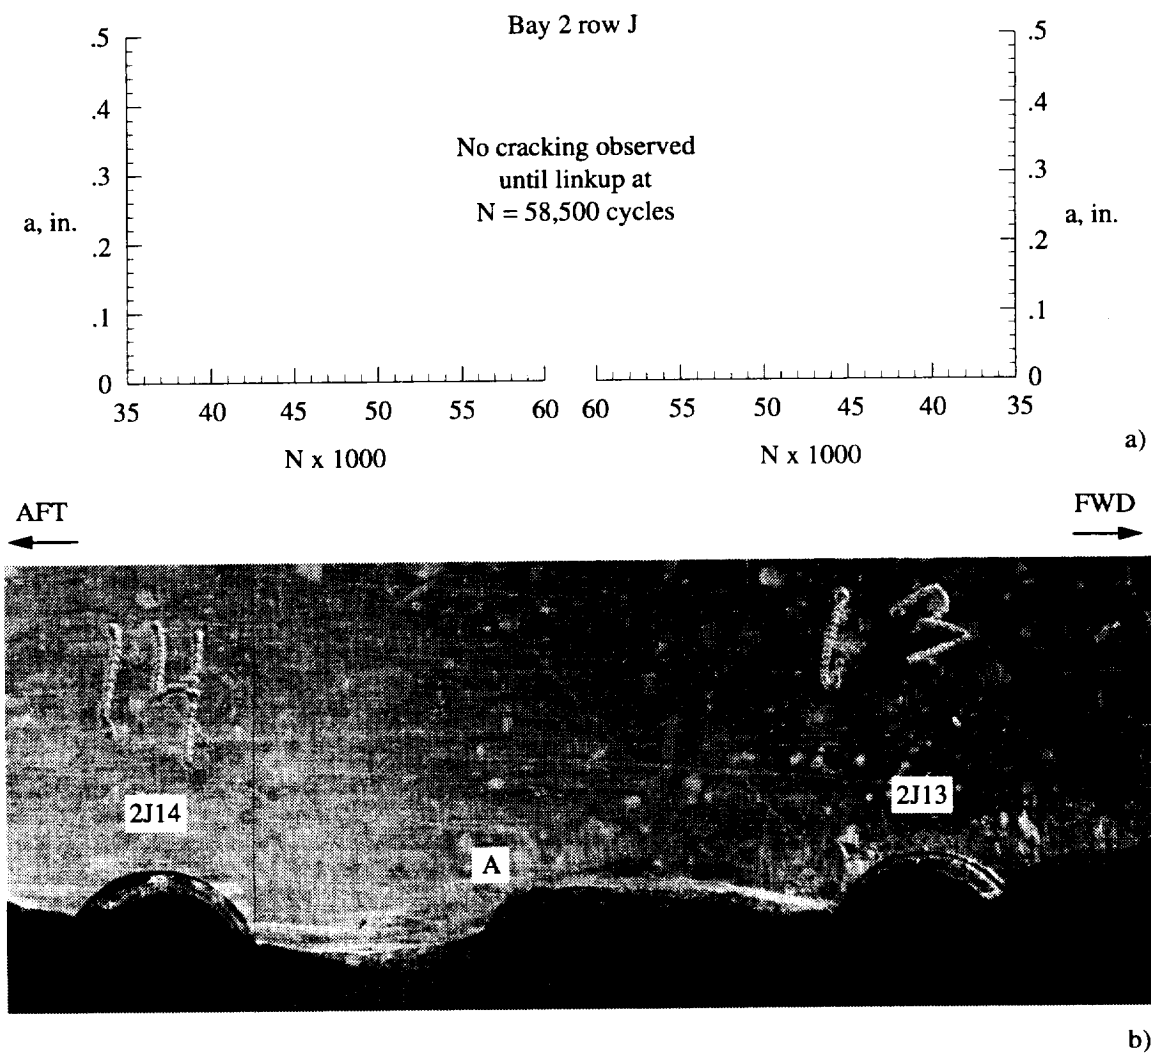
Figure 7.20 a) No visible cracks were observed between rivet holes 2J13 and 2J14 until after crack link-up. b) The photograph shows the upper portion of the crack surface between rivet holes 2J13 and 2J14. Region A is the likely location for crack link-up. Most of the crack surface shown in Figure 7.20.b exhibits a roughened appearance. This slant fracture region is characteristic of ductile tearing produced by relatively high crack tip stress intensity. The slant fracture region contains scratches normal to the direction of crack propagation indicative of fracture surface contact resulting from mode III displacement.

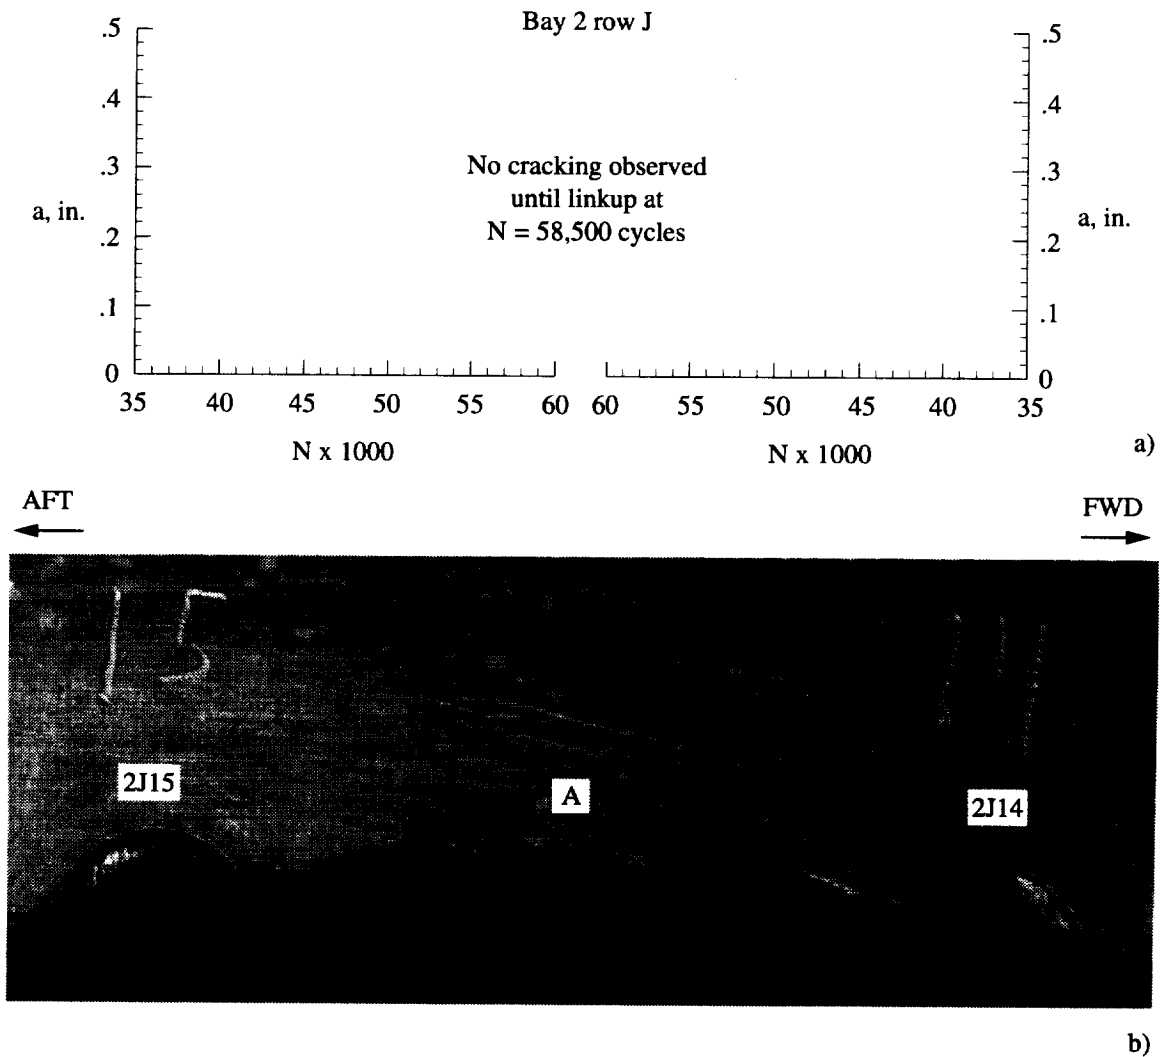
Figure 7.21 a) No visible cracks were observed between rivet holes 2J14 and 2J15 until after crack link-up.
 b) The photograph shows the upper portion of the crack surface between rivet holes 2J14 and 2J15. The region of crack link-up is less defined between holes 2J14 and 2J15, thus no crack link-up region is defined in Figure 7.21.b. Most of the crack surface shown in Figure 7.21.b exhibits a roughened appearance. This slant fracture region is characteristic of ductile tearing produced by relatively high crack tip stress intensity. The slant fracture region contains scratches normal to the direction of crack propagation indicative of fracture surface contact resulting from mode III displacement.

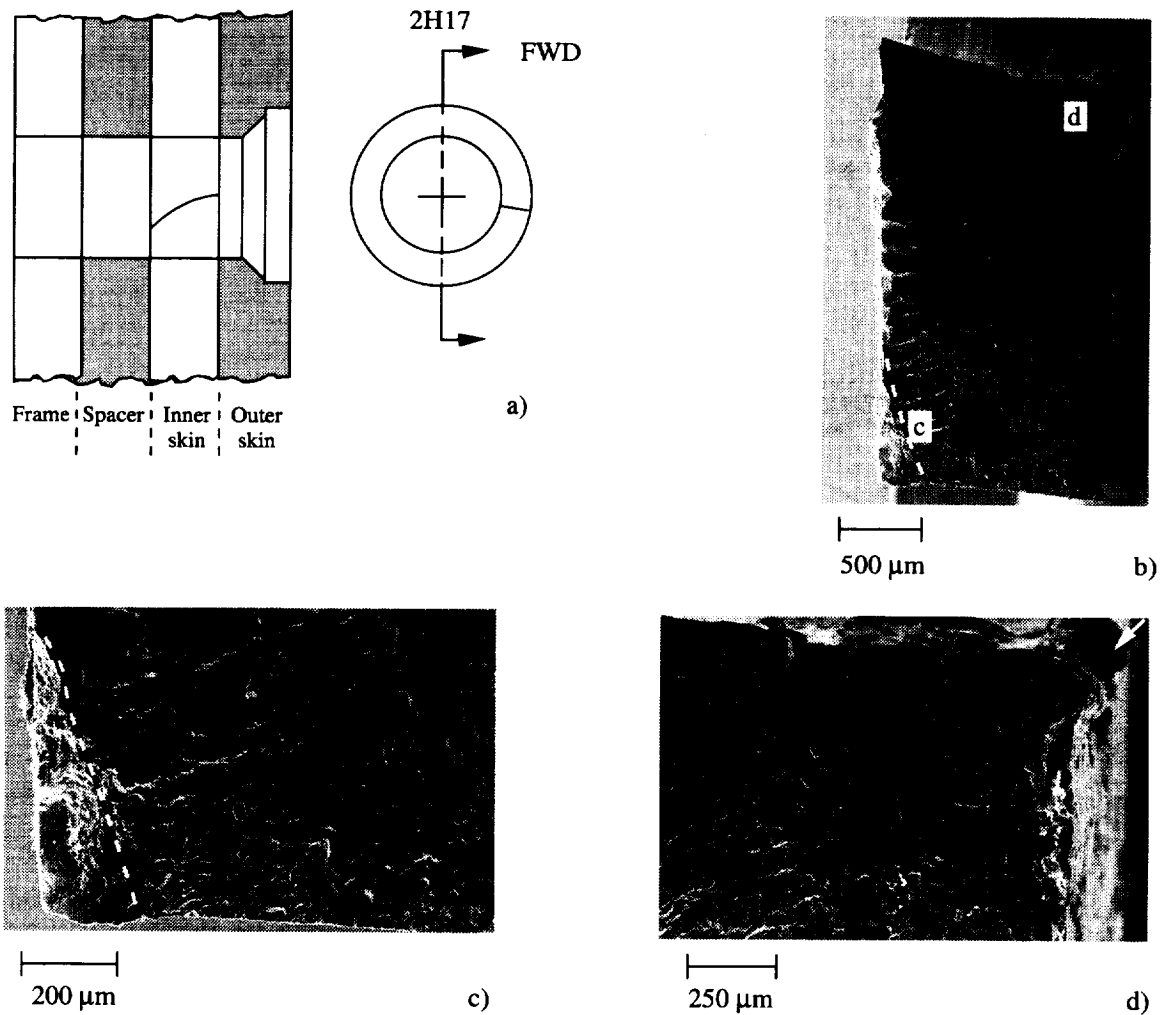
Figure 7.31 a) The schematic shows the rivet hole 2H17 configuration and the location of the inner skin fatigue crack oriented in the forward direction and about the 3 o'clock position. b) The SEM micrograph shows the fatigue crack fracture surface (the direction of crack propagation is from top to bottom of the figure) at the inner skin rivet hole which is located at the top of the micrograph. The fatigue crack was cut during the removal of the specimen from the panel and a portion of the fatigue crack surface is not shown in the figure. c) The SEM micrograph shows the fatigue crack surface at region "c" in Figure 7.31.b. The dashed line marks the remainder of the fatigue crack front. The crack front configuration suggests that the crack extends farther along the outboard surface of the inner skin compared to the inboard surface. d) The SEM micrograph shows the crack initiation region near the outboard corner of the rivet hole (region "d" in Figure 7.31.b). The region of crack initiation (arrow) along the outboard faying surface exhibits disturbed metal.

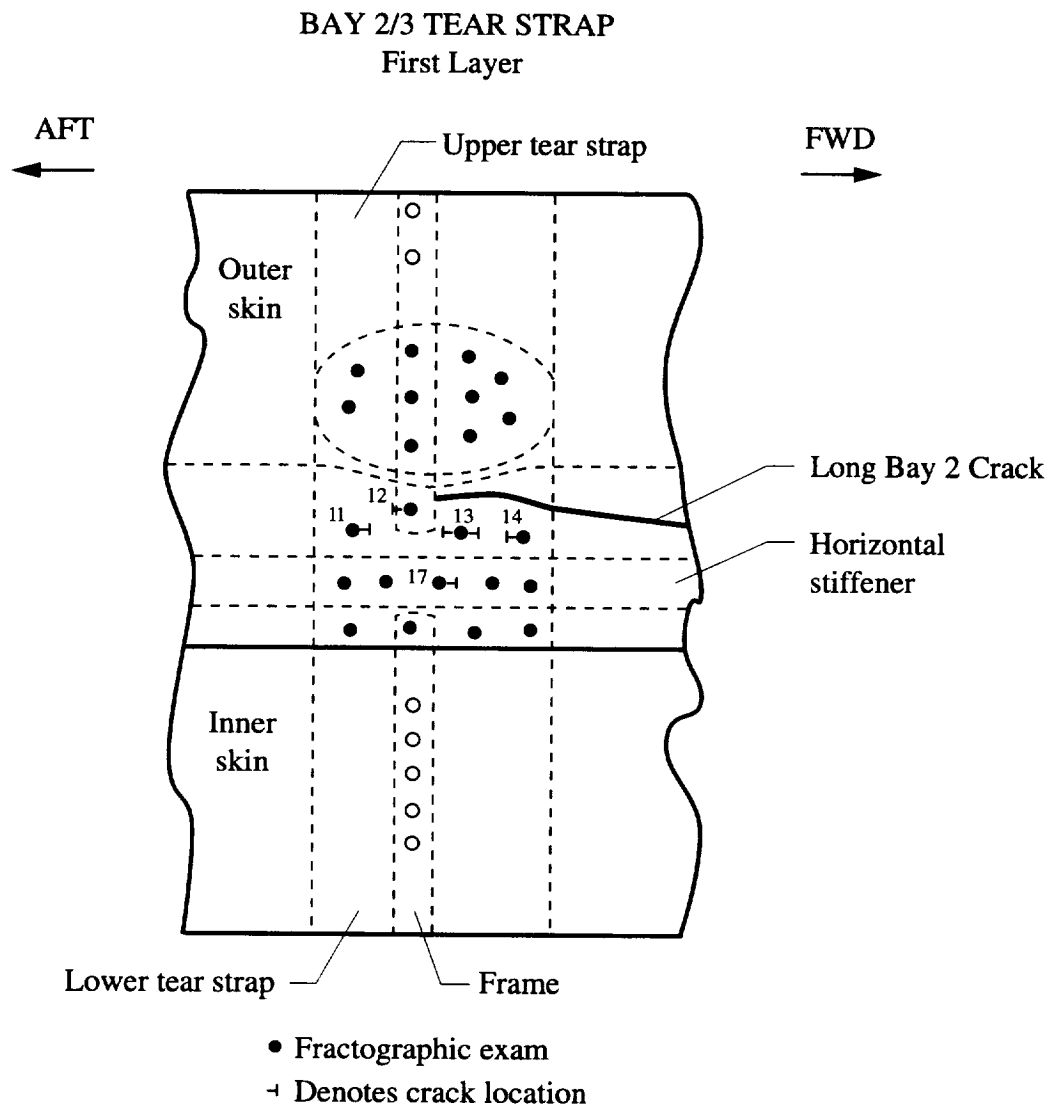
Figure 8.2 The schematic shows the location of fatigue cracks found in the first layer (outer skin) of the bay 2/3 tear strap by destructive examination. The solid dark line depicts one end of the long bay 2 crack extending into the tear strap.

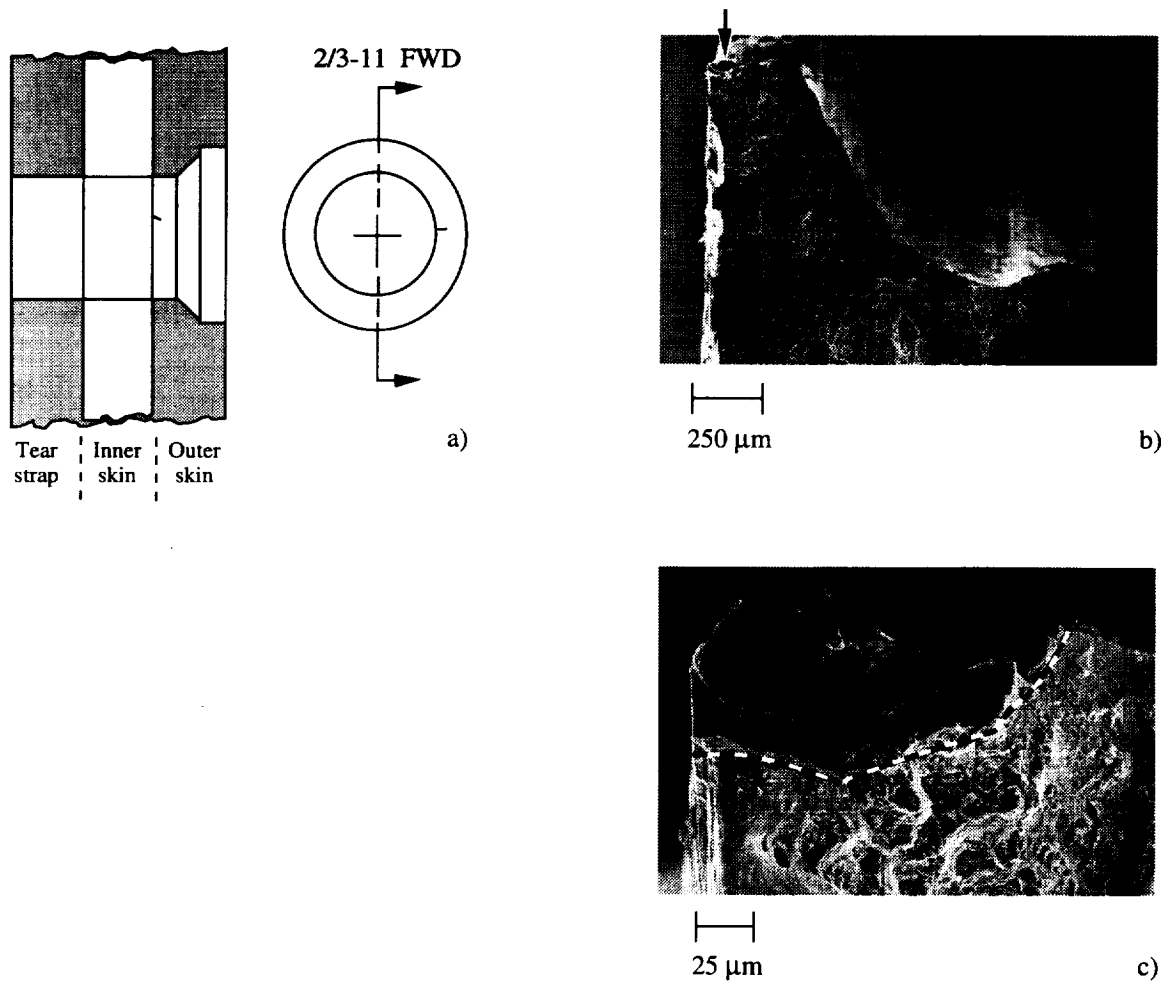
Figure 8.24 a) The schematic shows the rivet hole 2/3-11 configuration and the location of the outer skin fatigue crack oriented in the forward direction and above 3 o'clock position. b) The SEM micrograph shows the countersink region of the rivet hole. The arrow marks the location of the small fatigue crack at the rivet hole shank region. c) The SEM micrograph shows the small fatigue crack at the region marked by the arrow in Figure 8.24.b at high magnification.
